SOUTHERN AREA GROUNDWATER INTERCEPTOR TRENCH CONSTRUCTION & INSTALLATION REPORT

DETREX RD/RA
SOURCE CONTROL AREA
DETREX FACILITY
ASHTABULA, OHIO
DOCKET NO. V-W-98-C-450

Detrex Corporation
Ashtabula, OH

January 2008

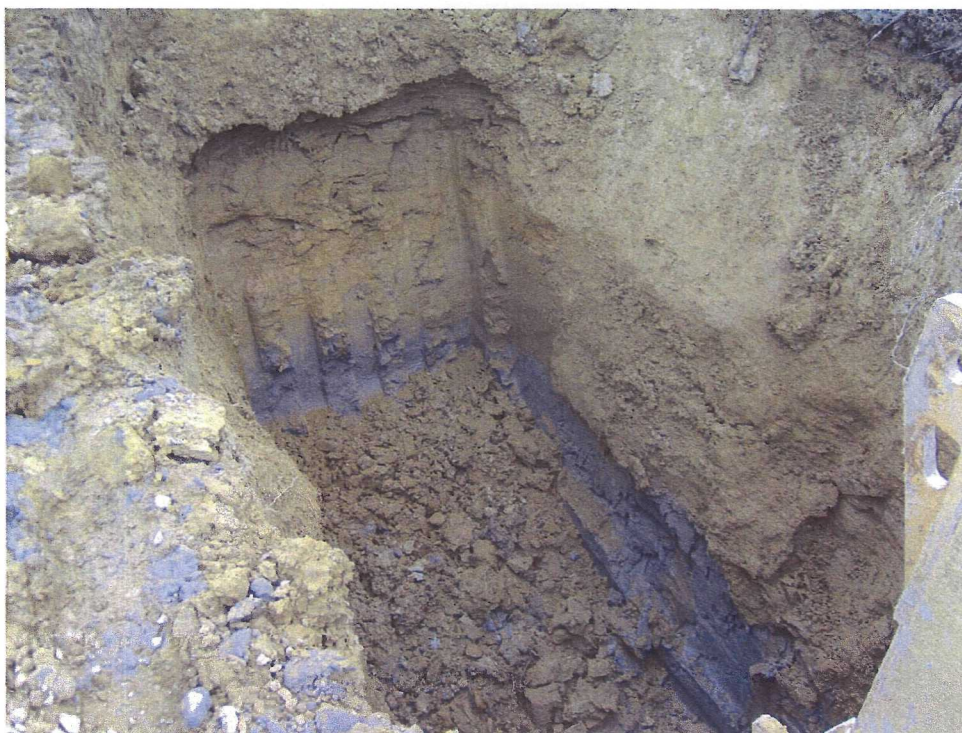
PHOTOGRAPH 68: Cave-in east of the trench box. Gray glacial till layer is visible where GWIT collection pipe is placed to grade.

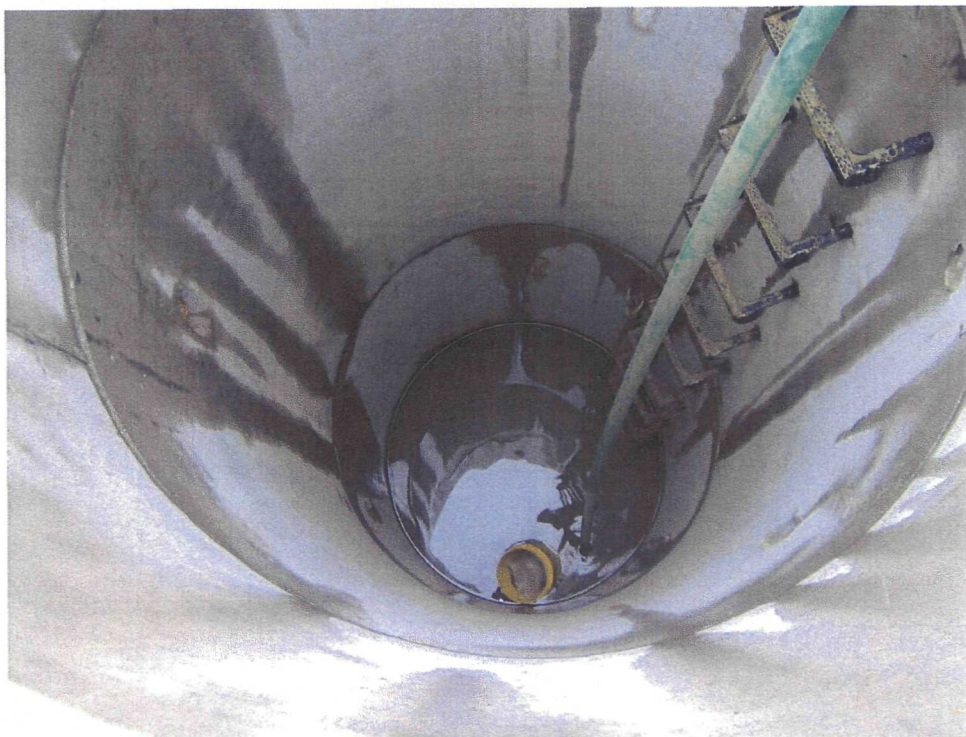
PHOTOGRAPH 69: Interior of GWIT Sump #1 after water had been pumped to the Waste Water Treatment GWIT Sump.

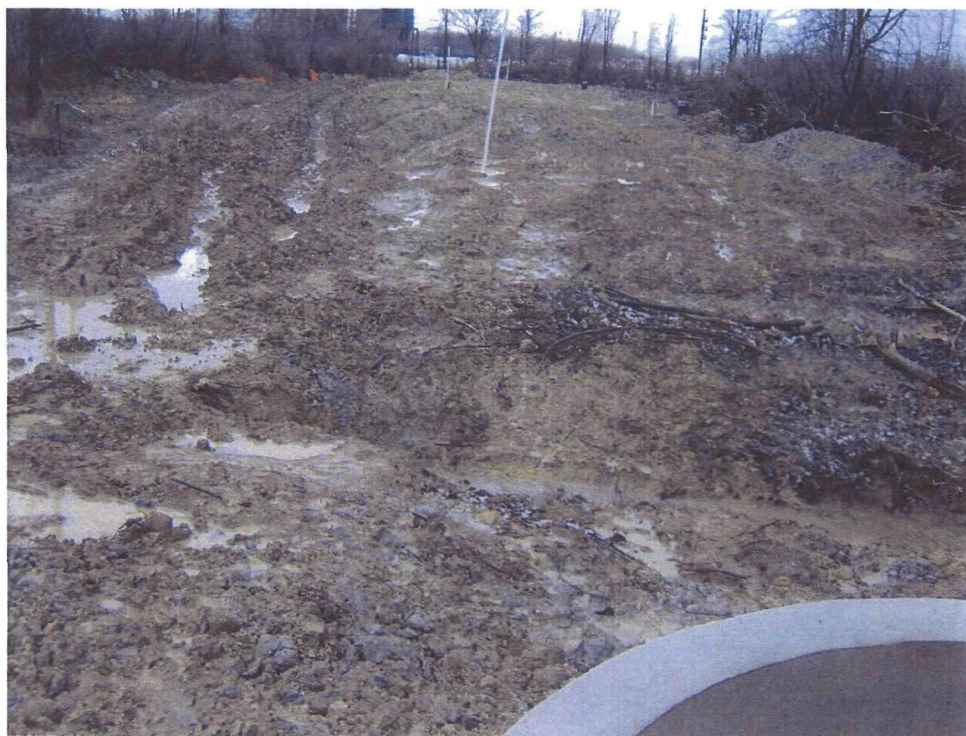
PHOTOGRAPH 70: Photograph of backfilled GWIT collection system east from GWIT Sump #2. Note the sample well approximately 150' to the east.

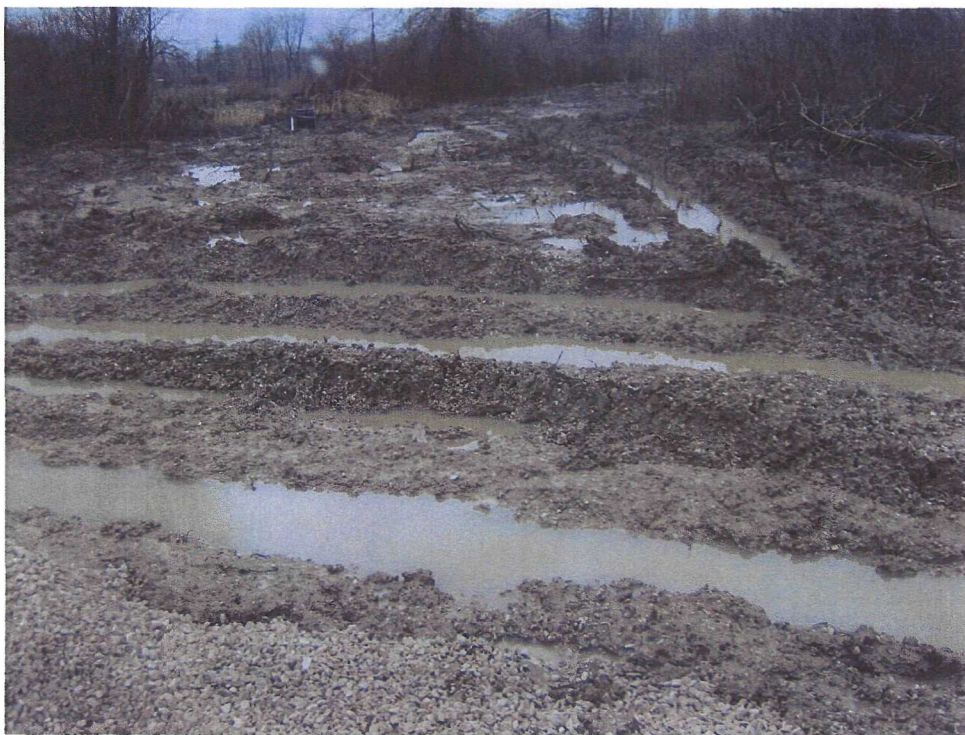
PHOTOGRAPH 72: Standing water and extremely muddy conditions encountered during the installation of the GWIT collection system east of GWIT Sump #1.

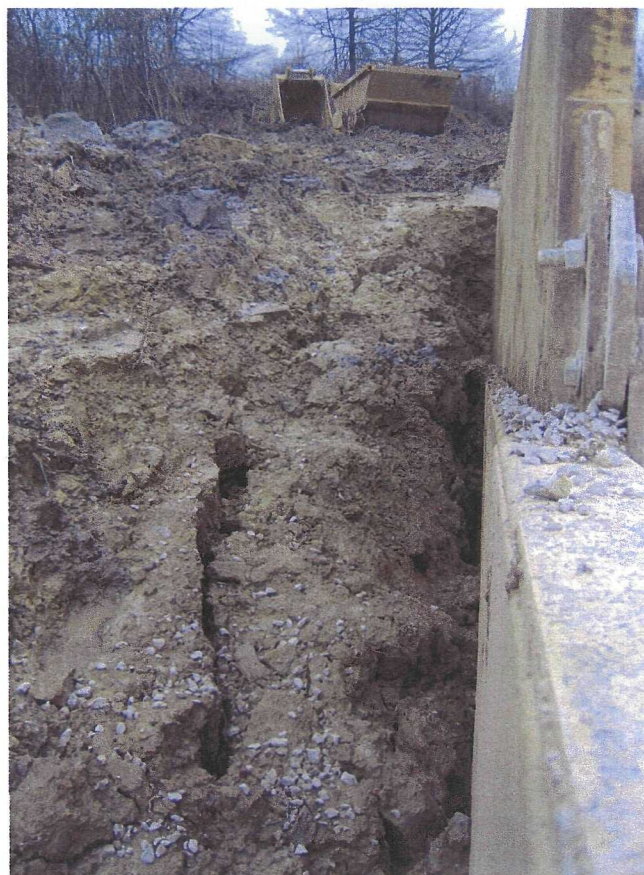
PHOTOGRAPH 74: Crack in the soil next to the trench box. Cracks would often reach 20' long during installation east of GWIT Sump #1.

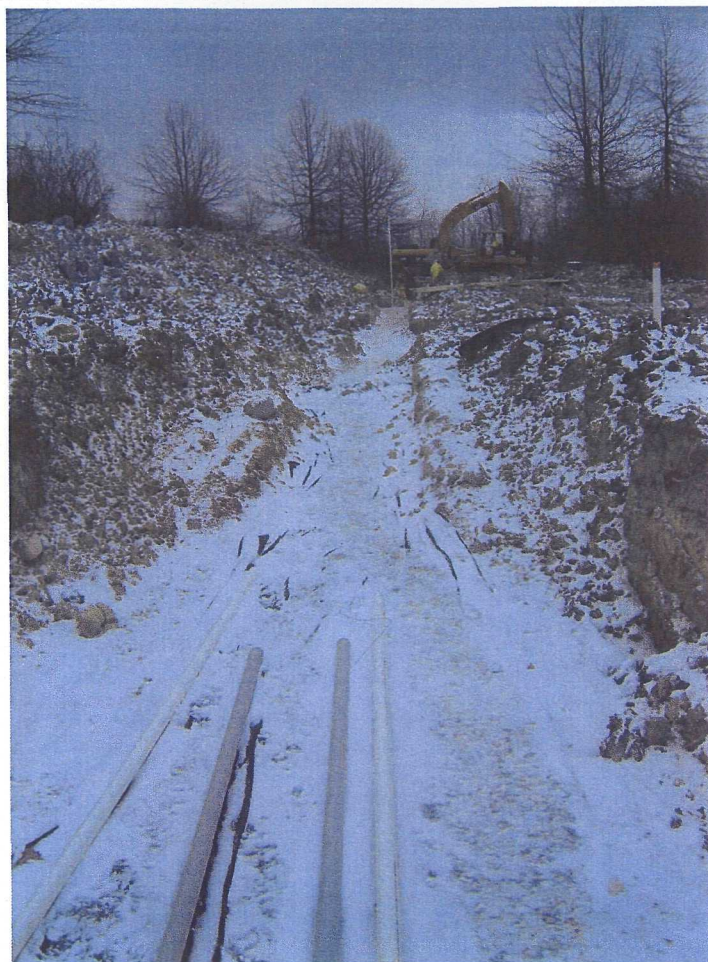
PHOTOGRAPH 75: Completed section of GWIT collection system covered with filter fabric to minimize the affects of cave-ins. Note the sampling well that was installed close to the back hoe. Sampling wells were placed 150' apart east of GWIT Sump #1.

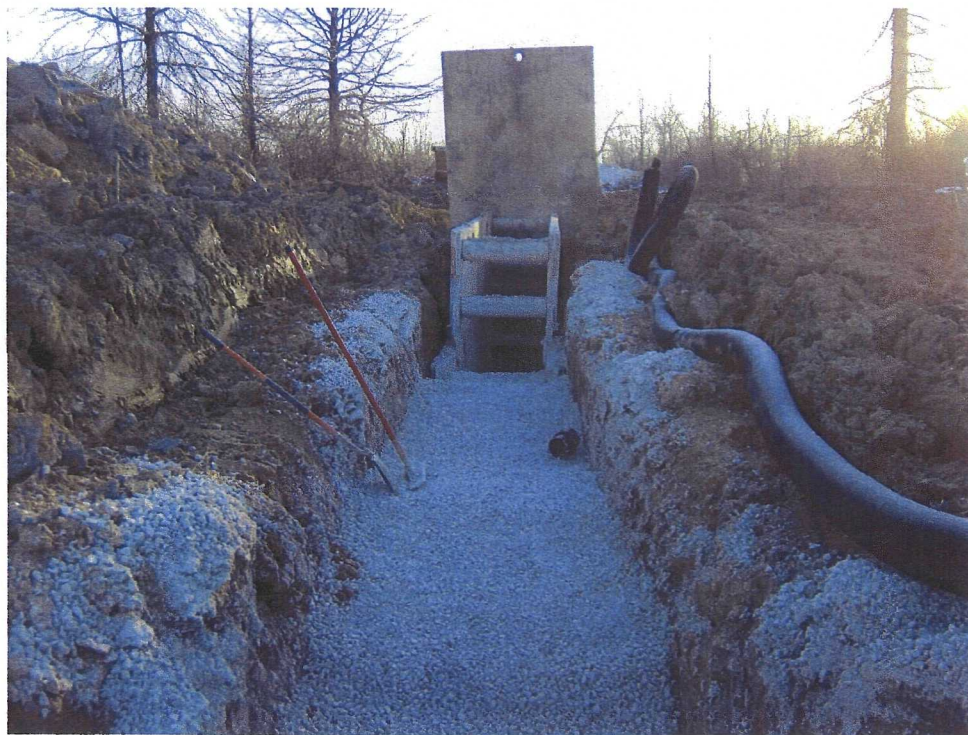
PHOTOGRAPH 76: Work area east of GWIT Sump #1 before excavation began. Note the steel sheet placed on the east side of the trench box to minimize cave-in's over night.

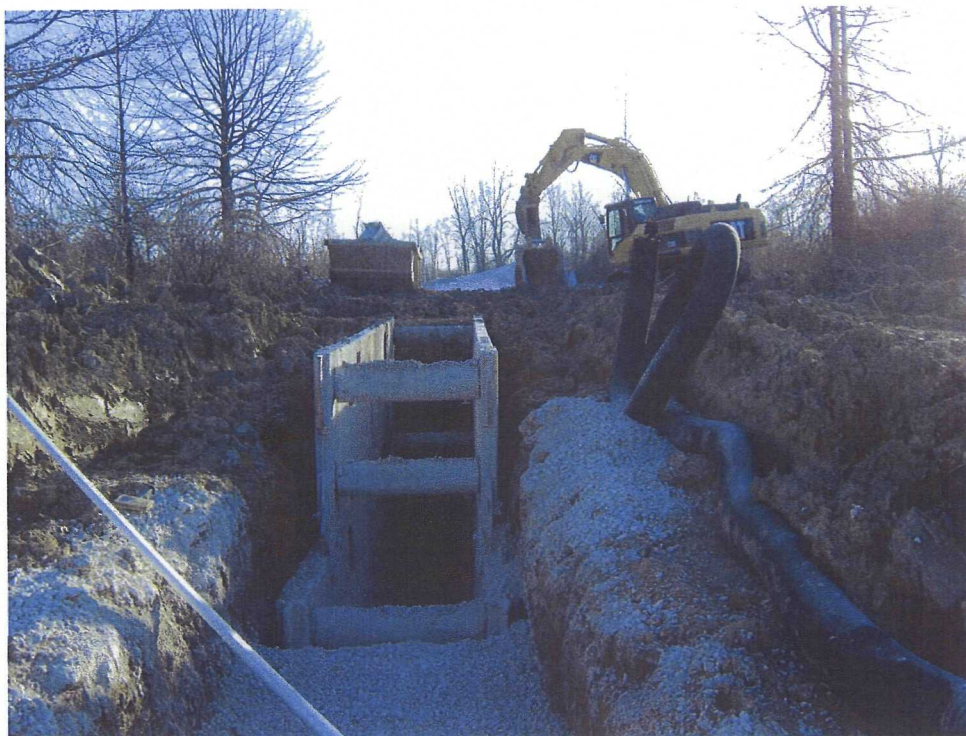
PHOTOGRAPH 77: GWIT collection system continues east of GWIT Sump #1.

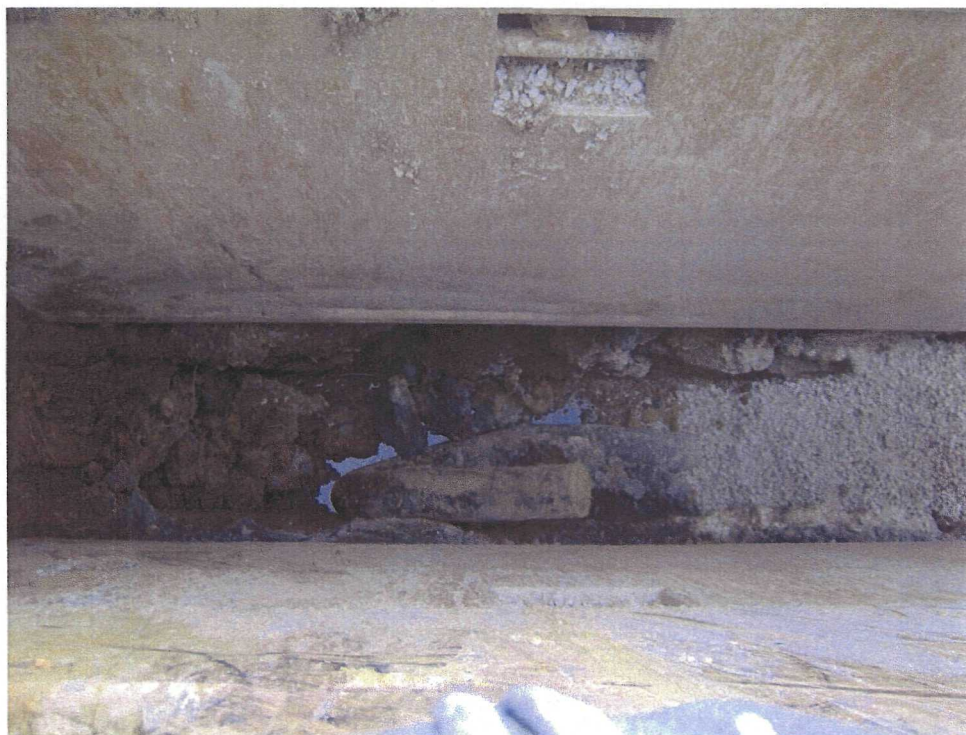
PHOTOGRAPH 78: Cave-in material inside the trench box. Note the GWIT collection pipe curling out of the gravel area.

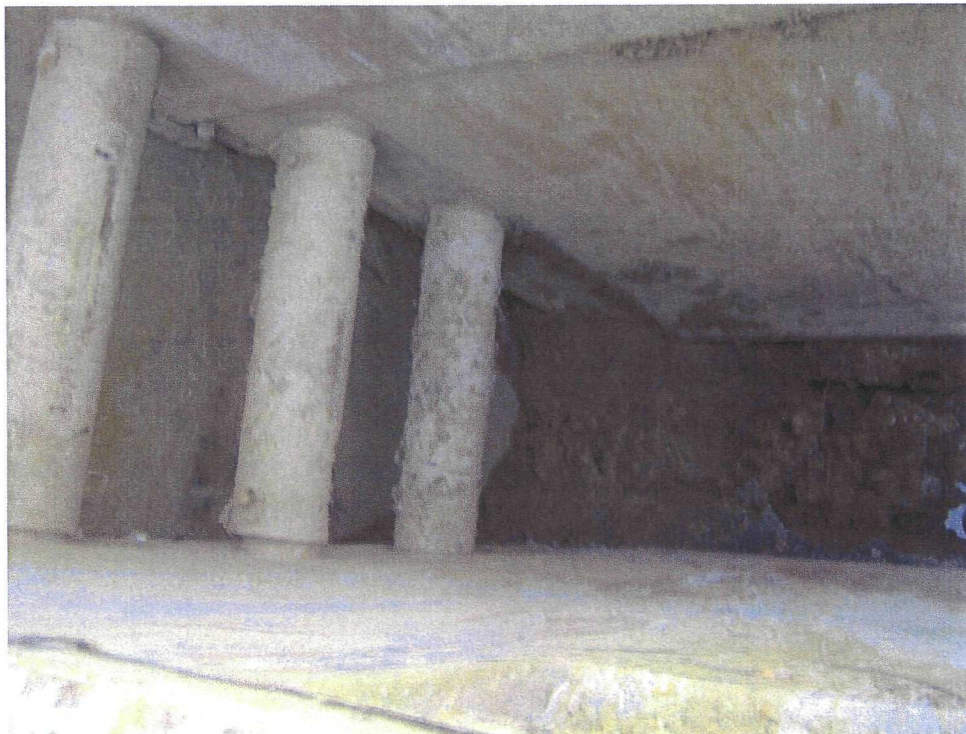
PHOTOGRAPH 79: Steel plate placed at the east end of the trench box east of GWIT Sump #1.

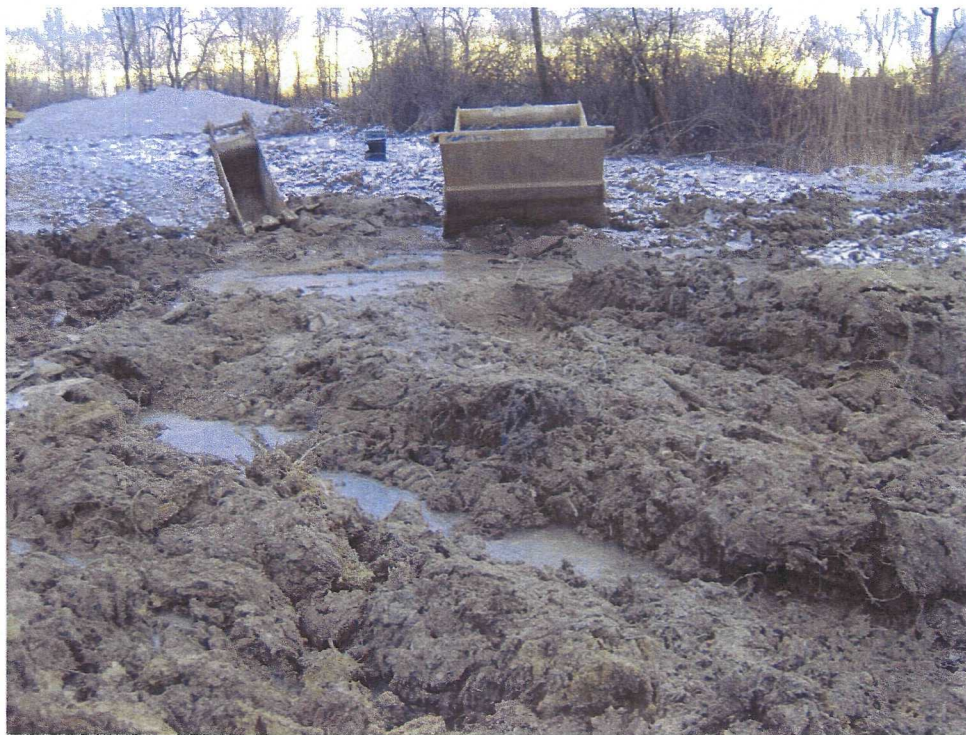
PHOTOGRAPH 80: Standing water and ice and extremely muddy conditions encountered during the installation of the GWIT collection system east of GWIT Sump #1.

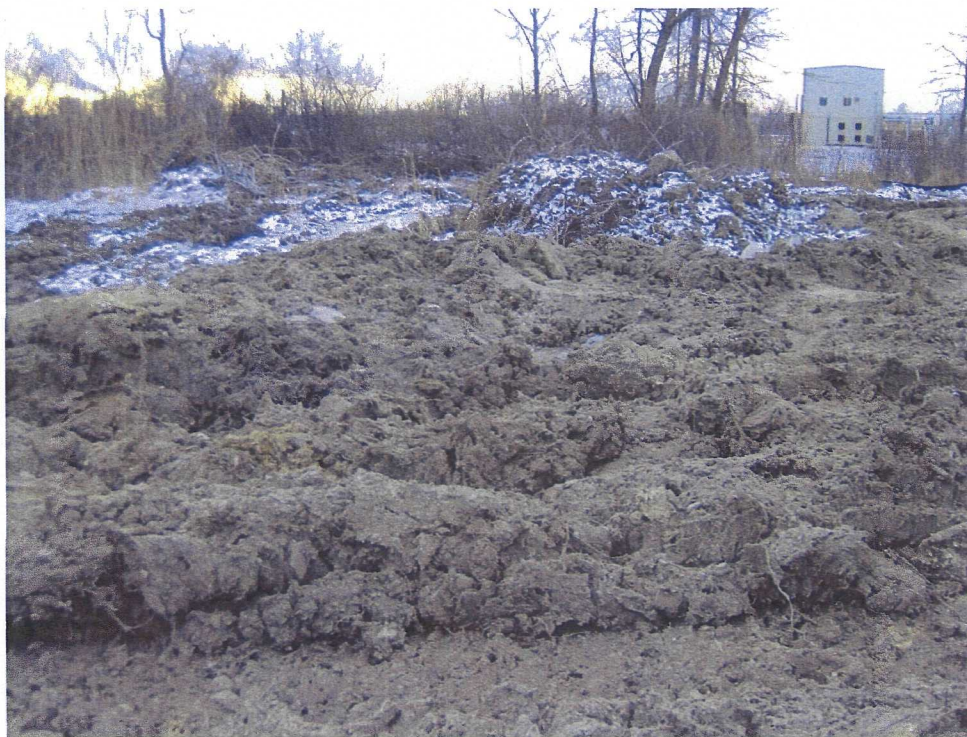
PHOTOGRAPH 81: Extremely muddy conditions east of GWIT Sump #2.

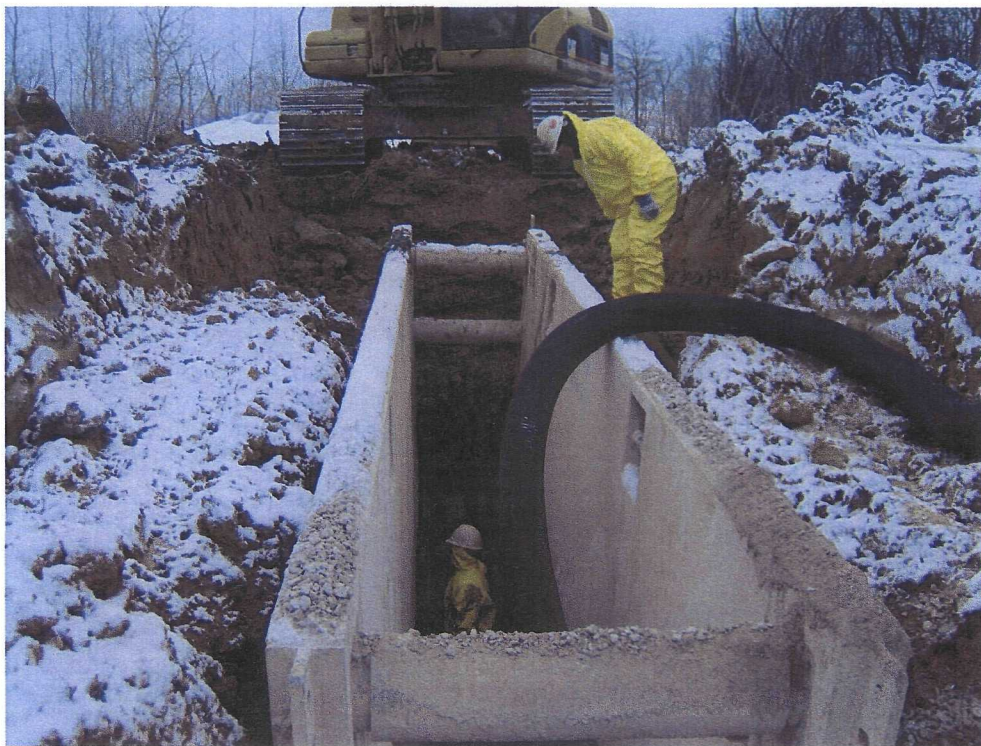
PHOTOGRAPH 82: Employee working inside the trench box east of GWIT Sump #1.

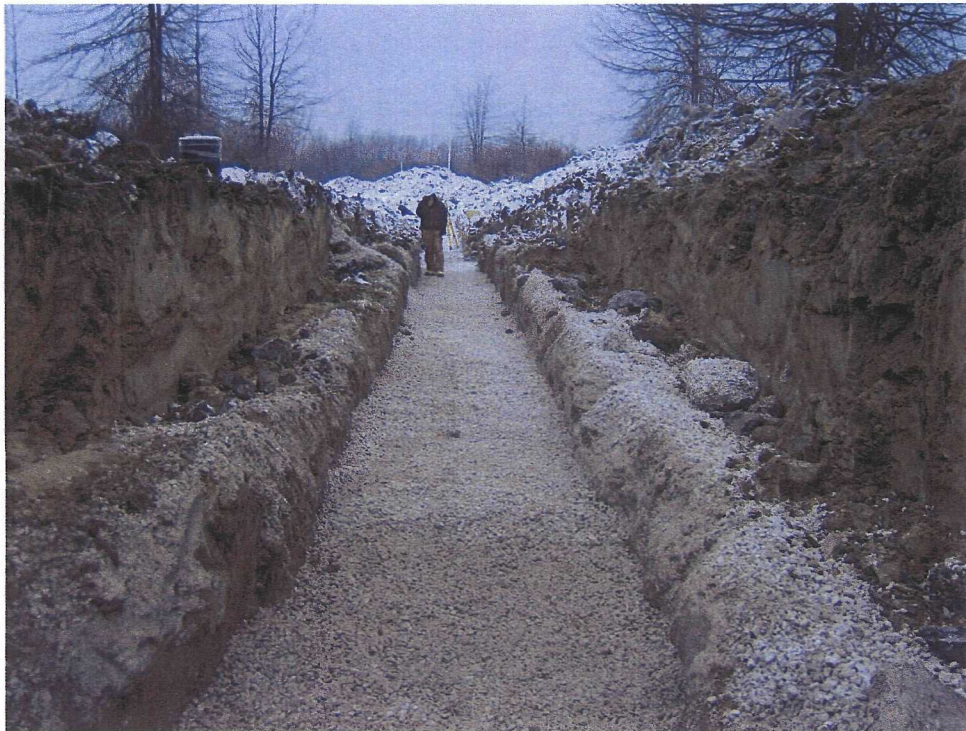
PHOTOGRAPH 83: Section of GWIT collection system that has been backfilled with gravel. Photograph taken facing the west toward GWIT Sump #1.

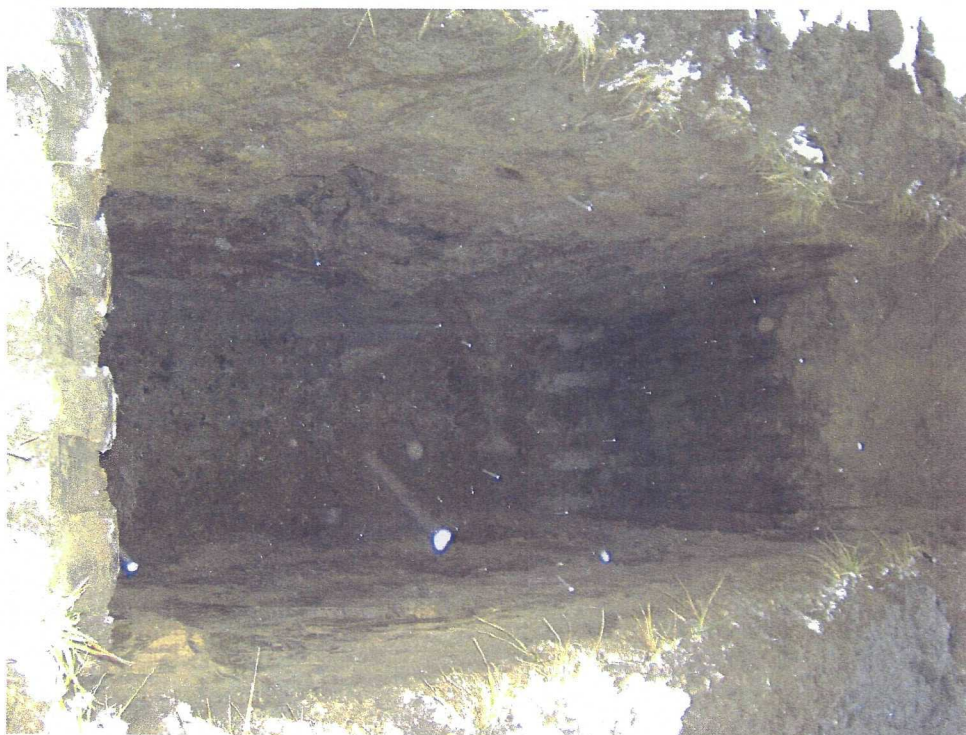
PHOTOGRAPH 84: Trench excavation east of GWIT Sump #1. Note the gray glacial till layer that GWIT pipe was placed in.

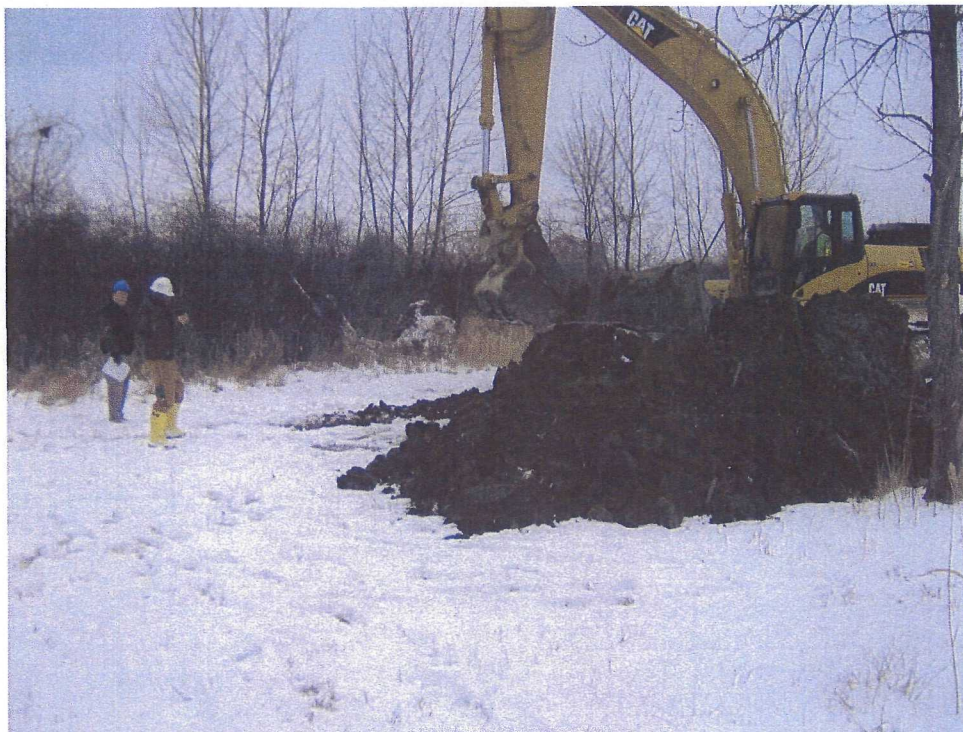
PHOTOGRAPH 85: Extreme eastern section of the GWIT collection system east of GWIT Sump #1.

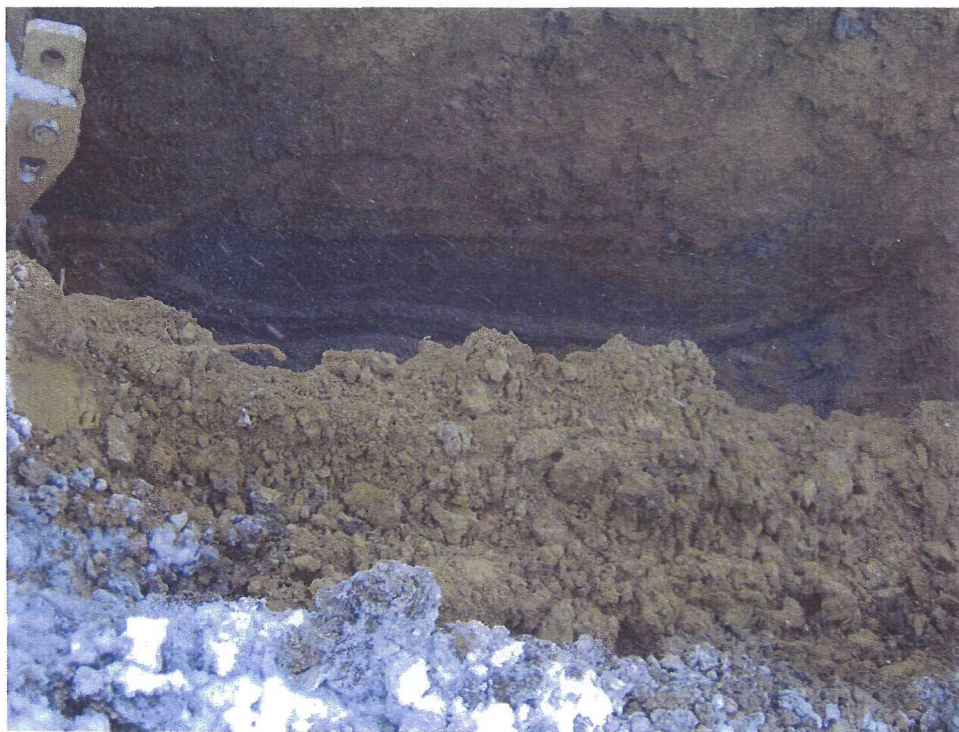
PHOTOGRAPH 86: Extreme eastern section of GWIT collection system east of GWIT Sump #1. Note the GWIT collection pipe placement inside the gray glacial till layer.
